Manhole Inspection Summary

Manhole # S43WW_013MH

Insp Date: **2/22/07 11:29 AM**

Location Address: **3220 KIRK AVE**

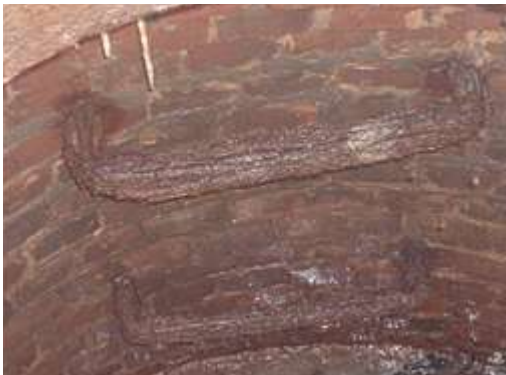
Defect

Condition: ☐ Sound ☐ Cracked ☐ Root Intrusion ☐ Deteriorated ☐ Leaks ☒ **Debris**

Channel debris.

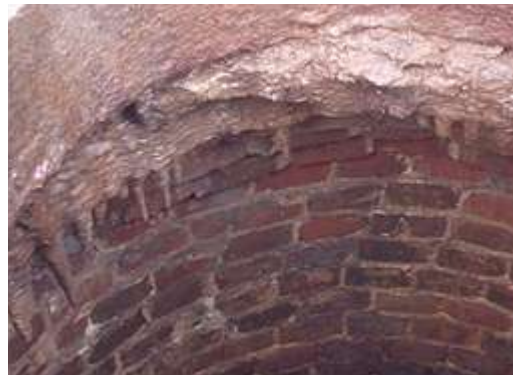
Defect

Steps Count: **2** Missing: **0** ☒ **Corroded**

Corroded steps.

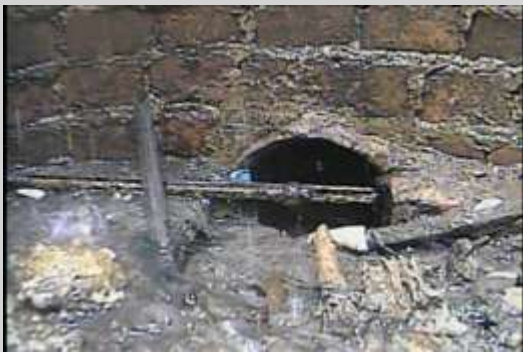
8 in. Circular Gravity Sewer Pipe Out @ 12 O'Clock

Deposits: ☐ None ☒ **Mud** ☐ Sludge ☒ **Debris** ☐ Grease

Silt Depth: **3** (in.) Deposits Extent: **Medium**

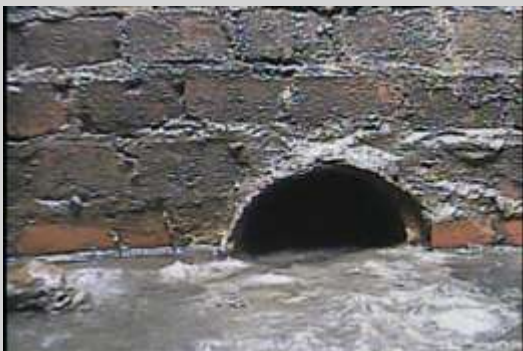
6 in. Circular Gravity Sewer Pipe In @ 4 O'Clock

Deposits: ☐ None ☒ **Mud** ☐ Sludge ☒ **Debris** ☐ Grease

Silt Depth: **3** (in.) Deposits Extent: **Medium**
